Application of ECO-RIPRAP riverbank protection model to improve bank stability and to support biotic community in Surabaya River

Abstract: Ecohydraulic river bank protection design was developed as ECO-RIPRAP model and has been applied along 100 meter length to restore accelerated erosion sites in Surabaya River at Wringinanom and Klubuk. The model combined re-profiled and re-vegetated bank with rock toe reinforcement and addition of log groynes at 10 meter length interval. Various native plant species were planted on bank slopes, including water plants *Ipomoea aquatica* and *Pistia stratiotes*, grasses and shrubs *Ipomoea carnea*, *Pluchea indica*, *Saccharum spontaneum*, *Arundo donax*, and native tree species *Ficus glomerata*, *Bambusa arundinacea*, *Dendrocalamus asper*, *Bambusa vulgaris*, *Ficus benjamina*, *Dillenia indica*, *Psidium guajava*, *Arthocarpus camansi*, *Arthocarpus elasticus*, *Hibiscus mutabilis*, *Nauclea sp.*, *Inocarpus edulis*, and *Syzygium polyanthum*. The river bank morphology after ECO-RIPRAP application showed alteration from erosion to sedimentation due to rock toe enforcement, log groynes protection, and increase of plant cover on littoral banks

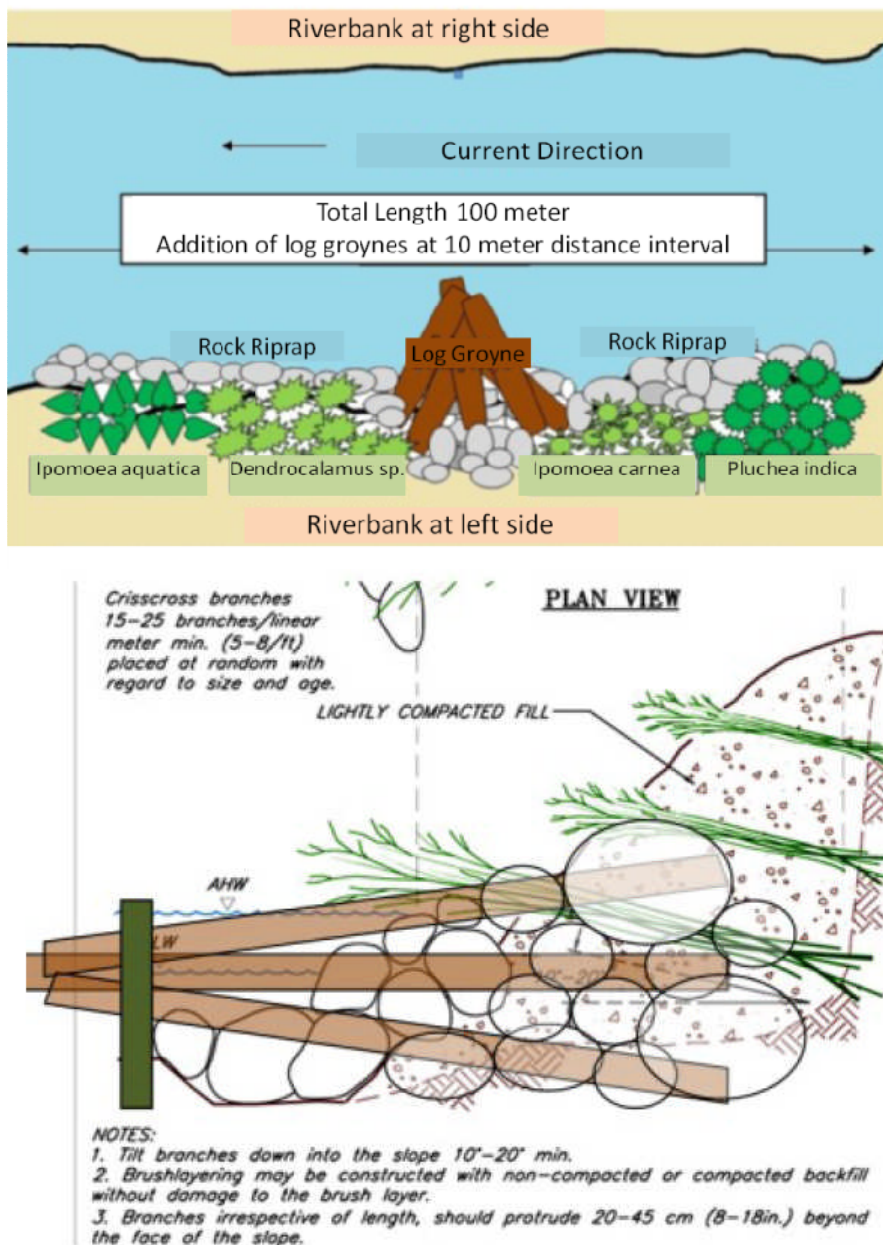
Figure 2. The design of ECO-RIPRAP bank protection model

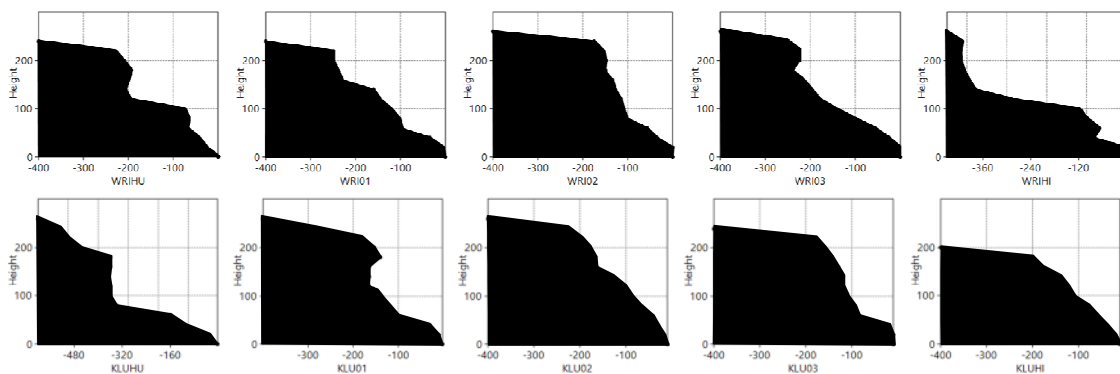
Figure 3. River bank morphology profile at eroded site in Wringinanom (top) and Klubuk (bottom)

impermeable roads. Some native riparian vegetation species can be seen on the banks, such as variety of bamboo and grasses, shrubs, liana, herbs, and tree species. The riverbank area along Surabaya River is bordered by earth dykes with riverbank boundary markers can be found along the dyke toe at certain kilometer distance from Mlirip Water Sluice. There were 18 accelerated eroded sites identified along 7 km section from Mlirip to Lebaniwaras. The length of eroded bank was range from 50 m to 200 m, and the river bank height was range from 1.5 m to 3 m. The bank slope at restored sites before ECO-RIPRAP model application was range from 41,3 - 60 degrees indicated that most part of eroded banks were steep and unstable. The bank morphology profile in Wringinanom and Klubuk is shown in Figure 3 and the condition of bank erosion is shown in Figure 4. River bank erosion occurs in Fish Sanctuary Area due to bank instability, increased

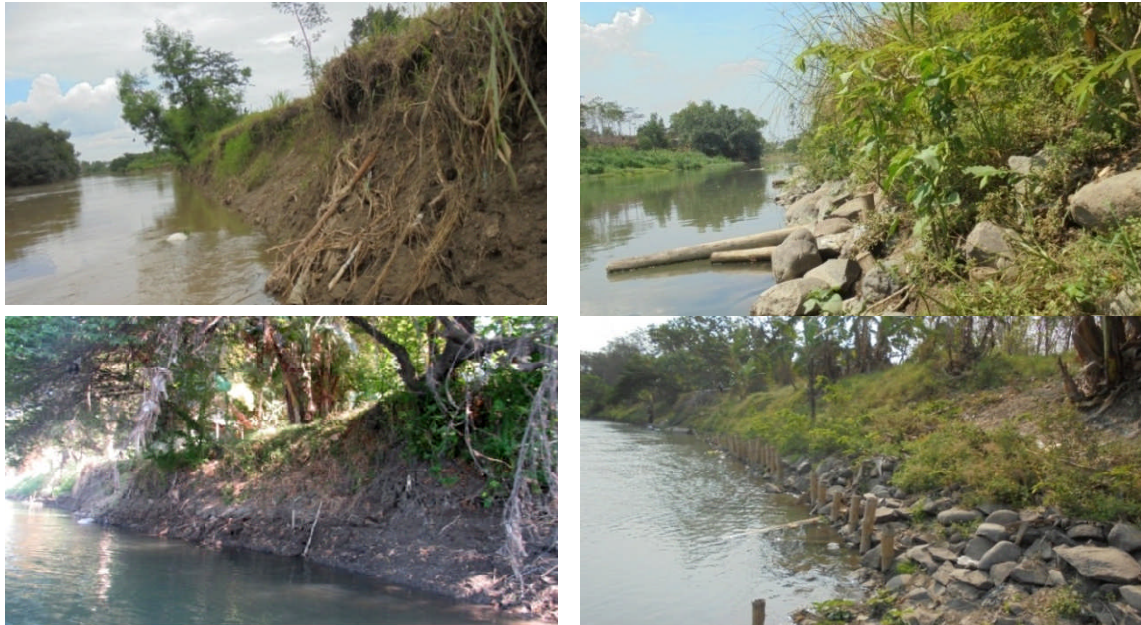
Figure 4. Riverbank condition before and after application of ECO-RIPRAP bank protection model in Wringinanom (top) and Klubuk (bottom)

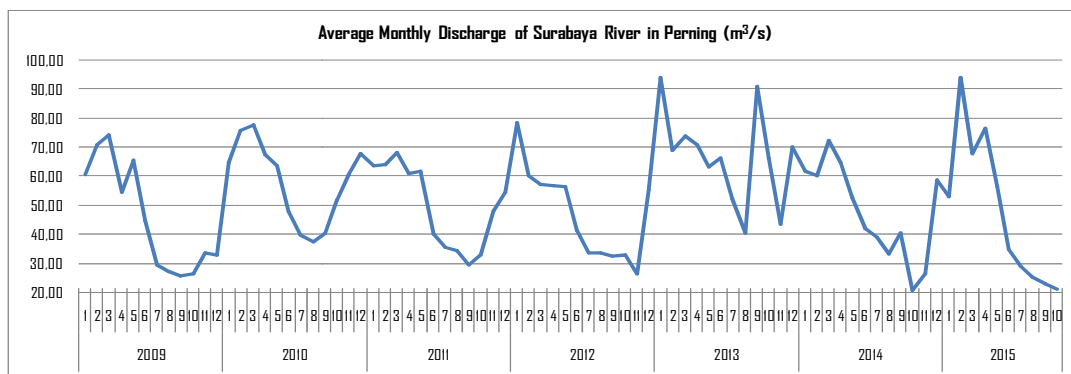
Figure 5. Hydrograph of Surabaya River in Perning

The graph in Figure 5 shows that discharge of Surabaya River during 2009 to 2016 indicated rainy season period occurred on December to May with average monthly discharge above 50 m³/s, range from 57.5 to 74.6 m³/s. Dry season occurred on June to November with average monthly discharge was less than 50 m³/s, discharge range from 31.52 to 48.33 m³/s. The highest average discharge was 94.21 m³/s that occur on January 2013 and lowest average was 20.58 m³/s that occur on October 2014. In year 2013, 2015 and 2016, the highest average discharge in rainy season was recorded above 90 m³/s. In 2013 and 2016, the average low discharge was above 40 m³/s that indicated less significant dry season.

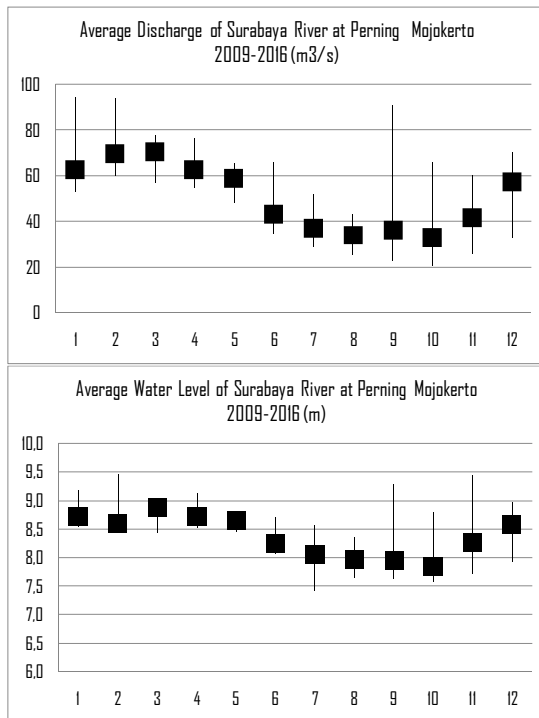
Figure 6. Average discharge and water level of Surabaya River 2009-2016

Figure 6 indicates that average monthly water discharge fluctuation in 2009 - 2016 has the same pattern with water level fluctuation. The wet season occurred in December to May, while dry season occurred in June to November. The water elevation in Kali Surabaya was range from 7.4 to 9.5 meter that maximum water level fluctuation was 2.1 meter. During wet season, water level increase causes periodic floods in riverbank area as natural entity that maintain balance of hydrological cycle in river ecosystem. The floods also create littoral habitat extension for fish and river organisms as refuge area from fast current. Flood management in some developed countries has been shifted from flood control to flood adaptation approach. The flood control relies on structural measures is not a sustainable solution for flood management. Indonesia has 5.590 main rivers, about 600 rivers have been severely flooded that leads to social problems and economic losts. The integrated flood management should adopt ecosystem-based disaster risk reduction. Ecosystems, such as wetlands, forests, riparian and coastal systems can reduce physical exposure of natural hazards. Restoring catchment vegetation along the riverbank reduces surface runoff that will reduce flood damages, particularly in smaller events. Natural green belt serves as natural protective barriers or buffers and thus mitigating hazard impacts of floods (PEDRR, 2010).

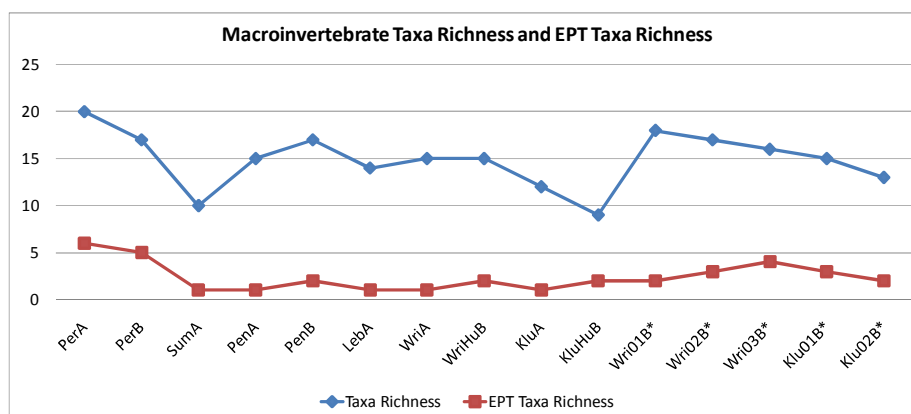
Figure 8. Taxa richness and EPT taxa richness in macroinvertebrate community

River increased of taxa richness, EPT taxa richness, %EPT and %Atyidae, and decreased of %Chironomidae in macro invertebrate community (Figure 8). The fish community at restored sites in Wringinanom and Klubuk reach showed increased of taxa richness, increased of fish abundance by 54,2%, increased of abundance of *Pangasius micronemus* by 25,6%, and increased of abundance of *Hemibragus nemurus* by 6,3 % in Wringinanom - Klubuk reach (Figure 9). The rare fish species also found at treatment area in Wringinanom - Klubuk reach, namely *Oxyeleotris marmorata*, *Mastacembelus unicolor*, *Hampala macrolepidota* and *Notopterus notopterus*. Fish larvae and juveniles were spotted under log groynes, boulder and water plant's roots in the edge water column.

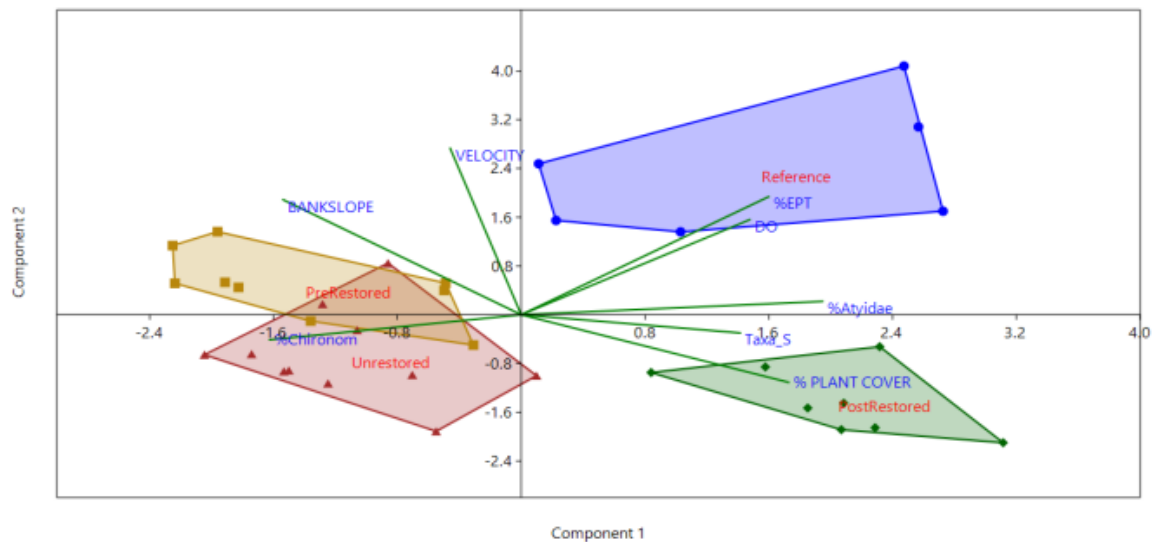
Figure 10. PCA Analysis result

invertebrate attributes. The results shown there were three groups of site distribution that complement with research site groupings as shown in Figure 10.

The reference group laid at upper right quadrant, the post-restored group laid at lower right quadrant, and the unrestored laid through pre-restored at middle left quadrant. The important parameters at reference sites were near-bank velocity, Dissolved Oxygen (DO) and %EPT. Those parameters at reference sites are significantly higher compared to other groups. Dissolved oxygen was strongly correlated with %
